Site Name: Maass Farm
Site ID: MAASS
Practice: Saturated Buffer

Research Site Leader:
Dan Jaynes, USDA-ARS

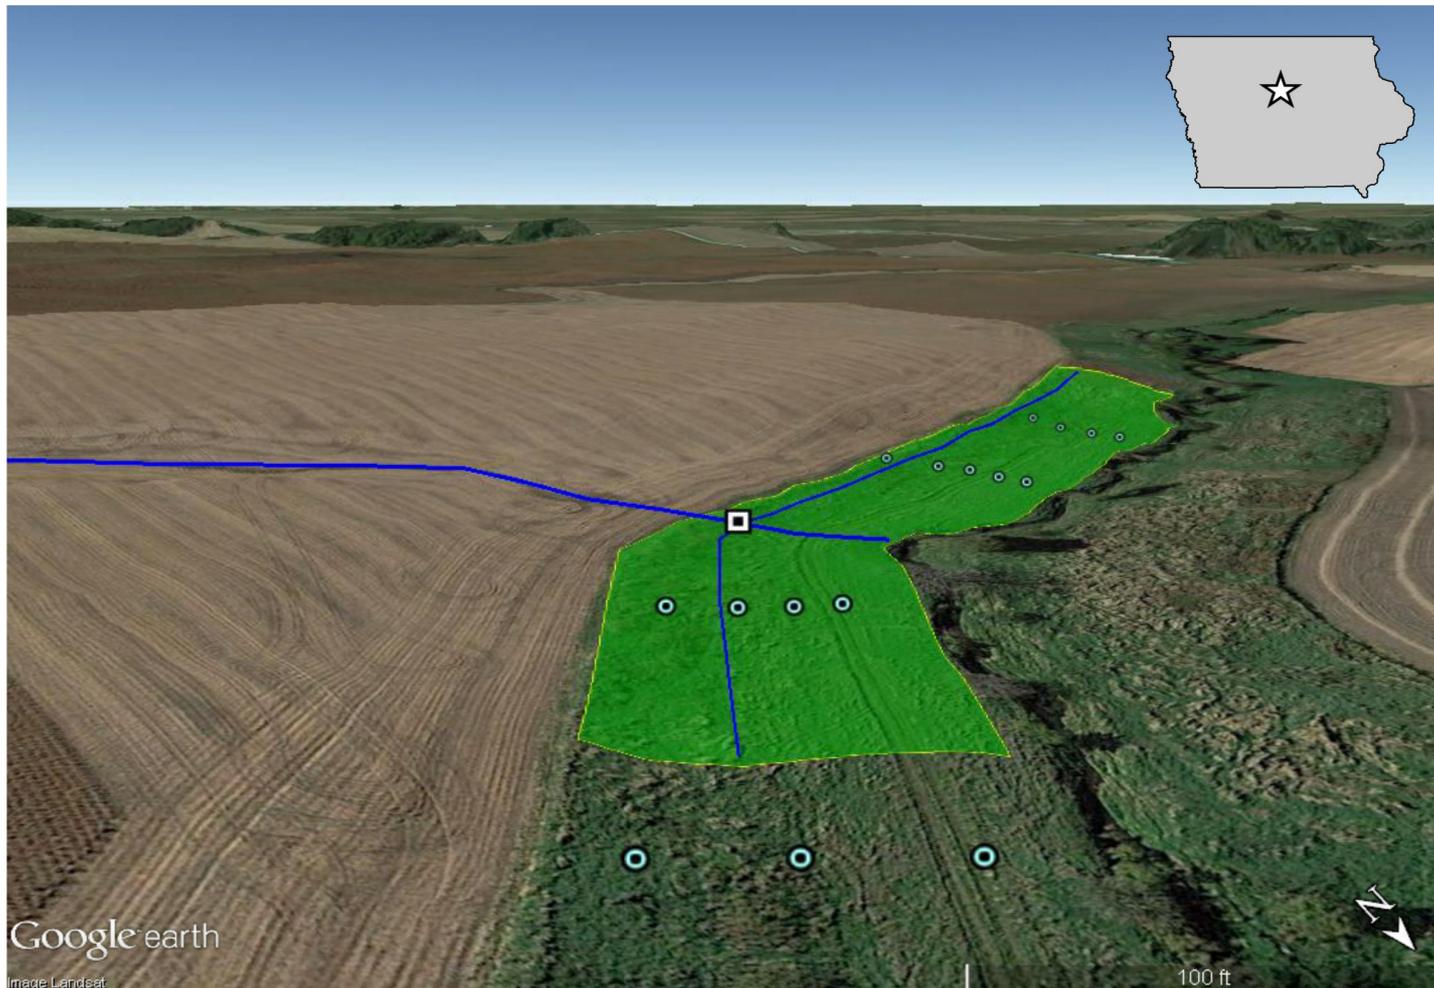
- Saturated Buffer zone installed in 2013
- Soil: Coland-Terril silty clay loam in riparian zone, clay loam and loam in upland field
- Intercepts tile flow from Corn-Soybean rotation (16 ac.)

- Saturated Buffer (depth 4', length 1000')
